Manhole Inspection Summary

Manhole # S17K__002MH

Insp Date: **2/19/08 11:23 AM**

Location Address: **2401 warwick ave**

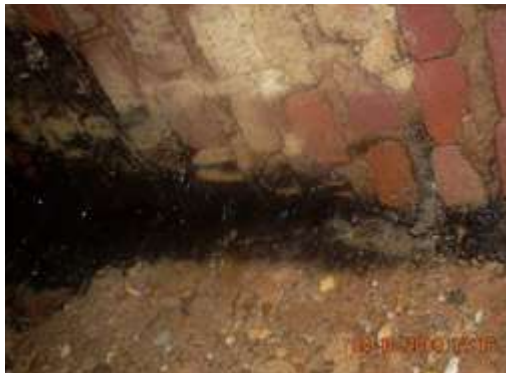
Defect

Infiltration: ☐ None ☐ Joint ☐ Cracks ☐ Mortar ☐ Roots ☒ **Wall**

infiltration of barrel wall

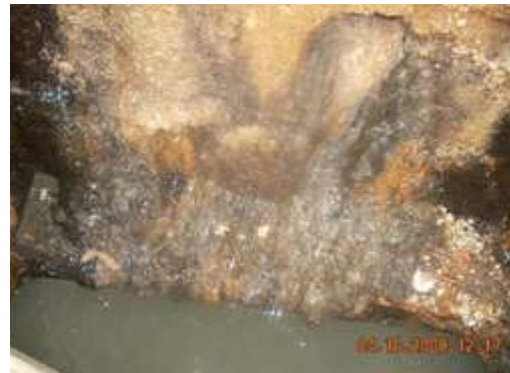
Defect

Condition: ☐ Sound ☐ Cracked ☐ Root Intrusion ☐ Deteriorated ☐ Leaks ☒ **Debris**

debris/concrete on bench and in channel

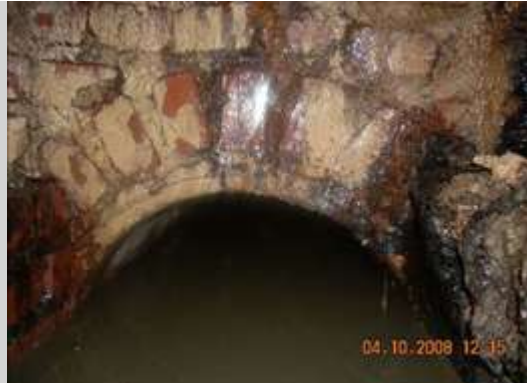
12 O'Clock Outflow

18 in. Circular Gravity Sewer
Pipe Out @ 12 O'Clock

Pipe Height: **18** (in.) Rod and Bar (Angled)
Pipe Material: **Clay** ☐ Pipe Lined
Invert Depth: **21.61** (ft.) Flow Characteristics: **Slow**
Deposits: ☒ None ☐ Mud ☐ Sludge ☐ Debris ☐ Grease
Silt Depth: **0** (in.) Deposits Extent:
Infiltration: **Evidence** Pipe Seal Cond: **Sound**

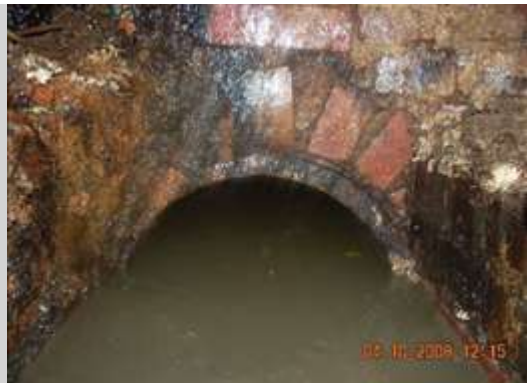
6 O'Clock Inflow

15 in. Circular Gravity Sewer
Pipe In @ 6 O'Clock

Pipe Height: **15.6** (in.) Rod and Bar (Angled)
Pipe Material: **Clay** ☐ Pipe Lined
Invert Depth: **21.52** (ft.) Flow Characteristics: **Slow**
Deposits: ☒ None ☐ Mud ☐ Sludge ☐ Debris ☐ Grease
Silt Depth: **0** (in.) Deposits Extent:
Infiltration: **Evidence** Pipe Seal Cond: **Sound**

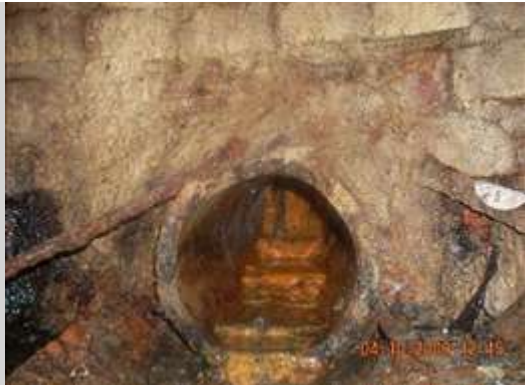
9 O'Clock Inflow

8 in. Circular Gravity Sewer

Pipe In @ 9 O'Clock

Infiltration: **None**
